PRESCRIZIONE di AERONAVIGABILITA'
	P.A. N° 2015 - 1 Data di Emissione: 20-05-2015
Il Certificato di Navigabilità dell'aeromobile sulle cui strutture od impianti deve essere applicata la Prescrizione di Aeronavigabilità in oggetto, scade di validità qualora essa non venga attuata nei termini prefissati.	
Detentore dell'Approvazione di Tipo: Aeromobili vari (Piper Aircraft Inc., FS 2000 Corp., FS 2001 Corp., FS 2002 Corp., FS 2003 Corp., Lavia Argentina S.A.(LAVIASA))	Tipi / Modelli: Aeromobili di cui all'applicabilità della AD FAA 2015-08-04 esclusi gli aeromobili Lavia Argentina S.A.(LAVIASA) costruiti dalla Piper
Prescrizione Estera: AD FAA 2015-08-04	
Supera PA: ENAC 2014-2 del 13-01-2014	
Oggetto: Struttura portante dell'ala	
Costruttore:	Aeromobili vari (Piper Aircraft Inc., FS 2000 Corp., FS 2001 Corp., FS 2002 Corp., FS 2003 Corp., Lavia Argentina S.A.(LAVIASA))
Applicabilità:	Aeromobili di cui all'applicabilità della AD FAA 2015-08-04 esclusi gli aeromobili Lavia Argentina S.A.(LAVIASA) costruiti dalla Piper.

2015-08-04 Various Aircraft: Amendment 39-18140; Docket No. FAA-2014-1083; Directorate Identifier 2014-CE-036-AD.

Procedures and Requirements for Ultrasonic Inspectio

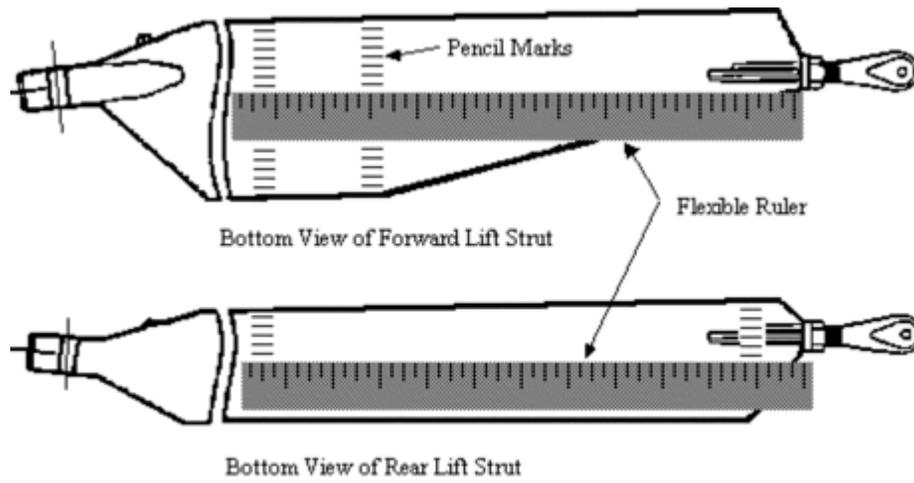
Figure 1

1. Clean the lower 18 inches of the wing lift struts using a cleaner that will remove all dirt and grease. Dirt and grease will adversely affect the accuracy of the inspection technique. Light sanding or polishing may also be required to reduce surface roughness as noted in the EQUIPMENT REQUIREMENTS section.

8. A measurement of 0.024-inch or less shall require replacement of the strut prior to further flight.
